Re: M/035/002 – Bingham Canyon Mine  
May 12, 2008 Order Vacating NOV #N2007-58-01  
Waste Rock Stability Study and Results of DAN-W  
Submittal of Revised Documents

This report entitled *Kennecott Utah Copper South Waste Rock Dumps Summary Report* ~~October~~ 2009 has been prepared to fulfil the requirement identified at Page 3, Item c. of the Order Vacating Notice of Violation N2007-58-01 for an off site excursion that occurred in July 2007. Specifically, Item c. states: "Undertake additional modelling and prepare a slope stability study to supplement the existing August 16, 2004 study, and update the 2003 Plan accordingly, as detailed in Attachment 3 to the March 20<sup>th</sup> letter.

This report summarizes a study investigating the long-term stability of the KUC waste rock (WR) dumps. The study goal assimilates the available historical data and begins quantifying the aspects of surface water infiltration, geochemistry and geotechnical conditions that contribute to WR dump stability. This report summarizes primarily information relating to the South End drainages, whose names are shown on Figure 1.

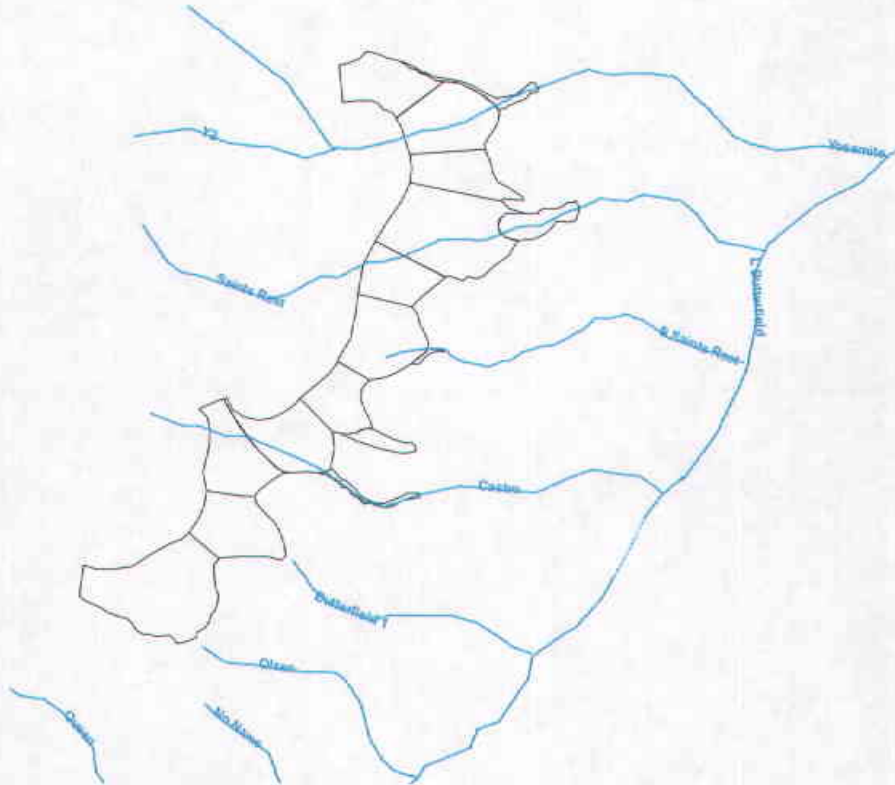
Figure 1 - Locations and drainage names for South End Dumps

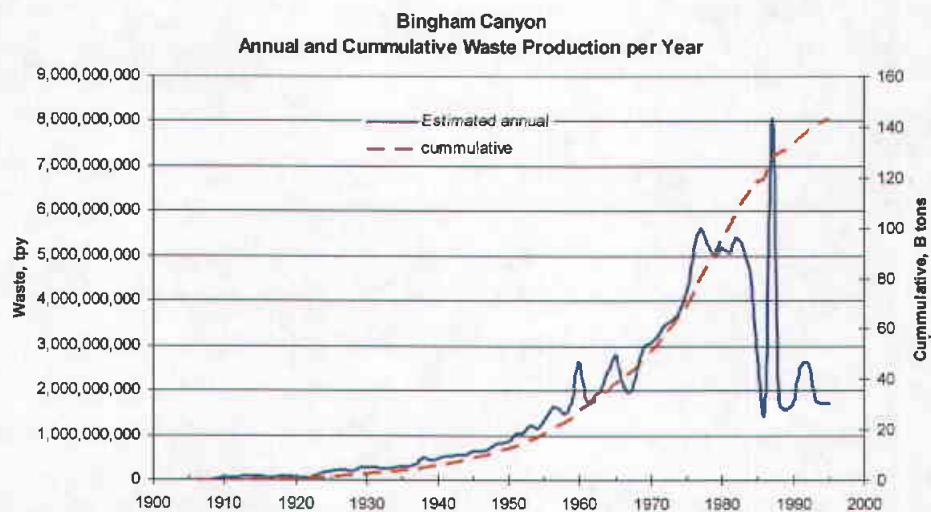
Figure 2 - Estimated waste placed at Bingham Canyon from beginning of open pit mining to the mid-1990's  
(estimated from ore production and stripping ratio)

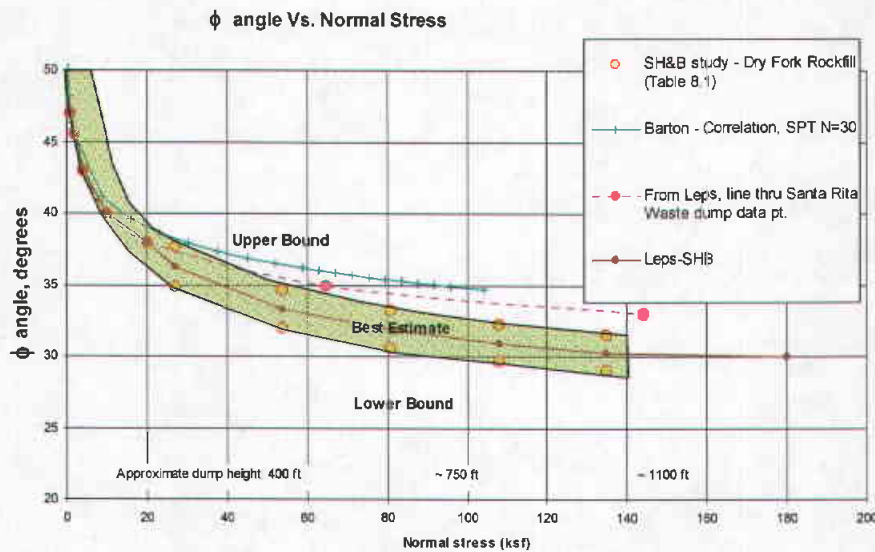
Figure 3 - Shear strength of rock fill based on Leps chart correlating rock fill shear strength to confining stress

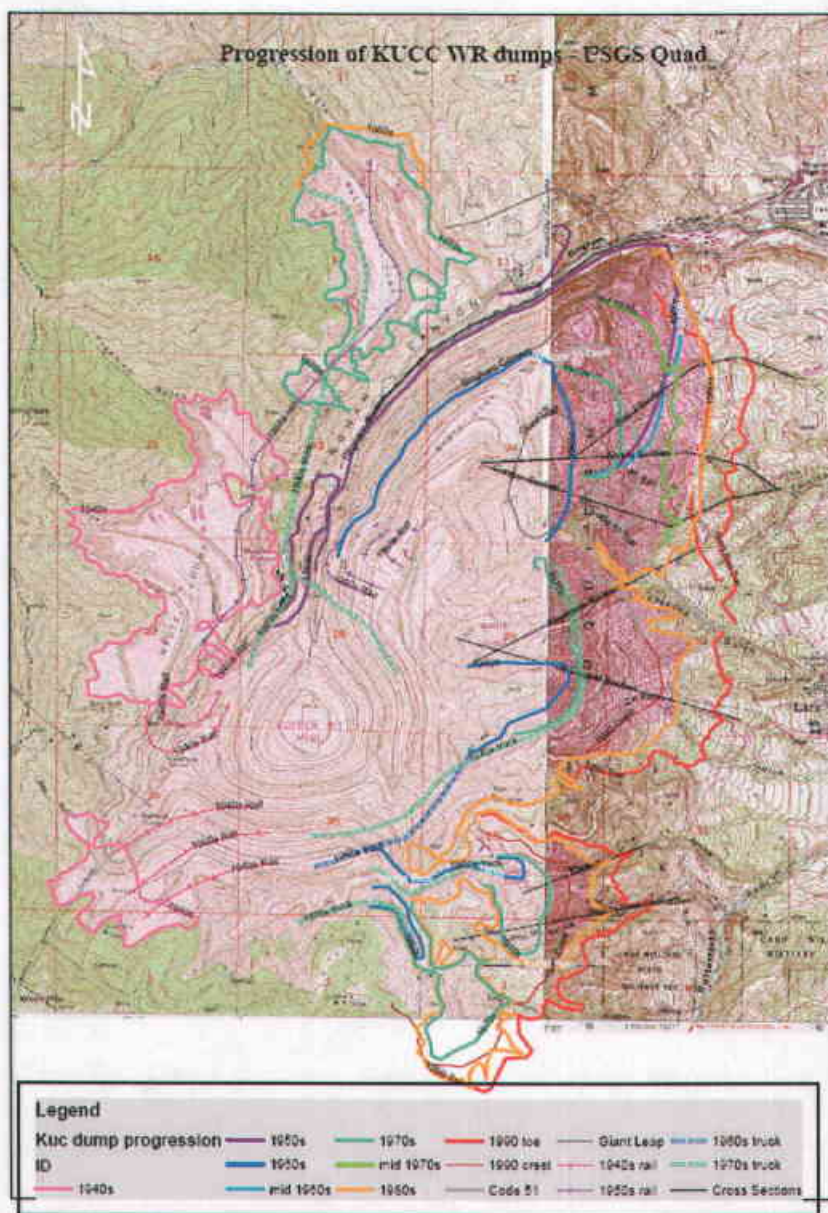
Figure 4 - Extent of dumping at approximately 10 year increments in time.

8	App A Page 16 Para 2	Dump map is Figure 4 and not figure 3 as written – apparent typo.	Correct reference has been provided.
9	App A Page 18 Para 2	DOGM does not believe that testing to a depth of 16.5 feet is indicative of the surface water infiltration rate throughout the entire column of all the south waste dumps area.	KUCC agrees with the comment on depths and number of investigations. However, the point was that these shallow investigations revealed a surface “base coarse layer.” The base coarse was placed across the entire dump surface by mine operations. Otherwise we agree that investigation of just the upper dump surface is not indicative of the entire dump. A discussion has been added describing the general permeability trend versus depth.

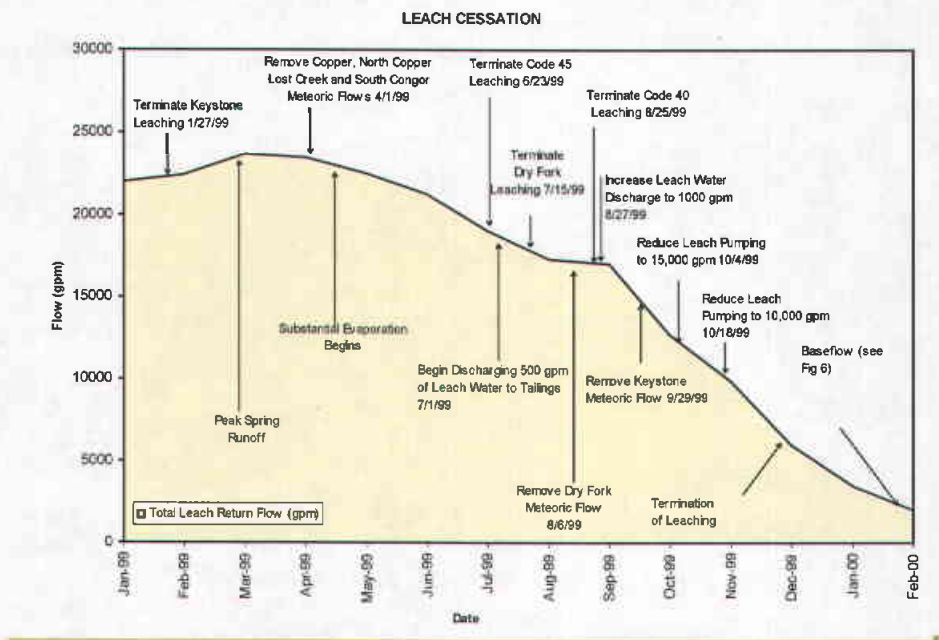
A plot of the East side collection system drain down from the period 1999 to 2000 following leaching is presented in Figure 5. Following the initial drain down, the annual cycles of water flow through the dumps and to the Eastside Collection System is shown on Figure 6. These plots reveal a permeable system that drains rapidly. The correlation between the Dry Fork (Snotel) data and the variation in the dump flow is shown on Figure 7 for the 2002-9 water years. These drain down flows are empirical evidence that the dumps are permeable and as a result are unlikely to support a high phreatic surface.

Figure 5 - Drain down of the Eastside dumps following cessation of leaching.

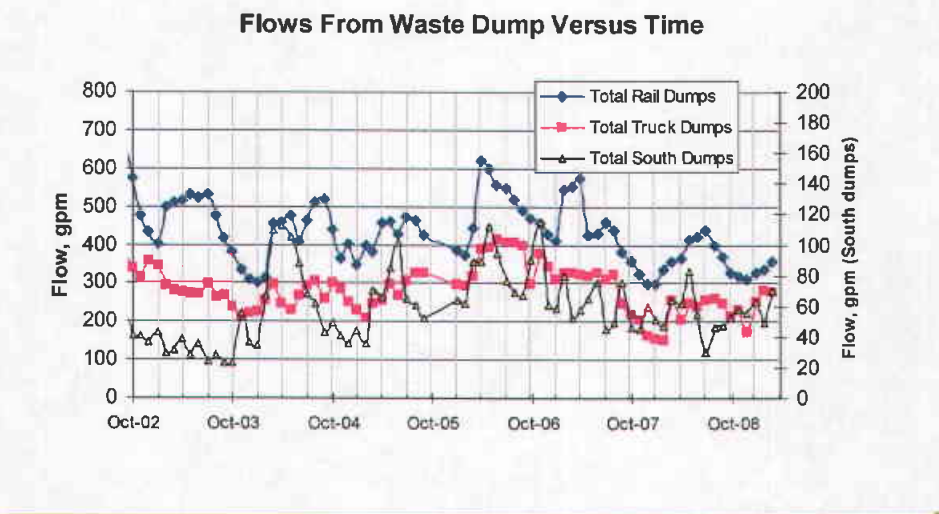
Figure 6 - East side collection system flows following initial drain down showing annual meteoric cycles of flow.

10	App A Page 19 Para 1	Plot the results from the leach flow monitoring system using meteoric fluctuations versus time and at a scale the shows the relation of seasonal fluctuations to the surface water infiltration rate, compared to the monitoring system data output.	Figure 5 has been corrected to remove the “planned termination of leaching” and Figure 7 has been added to show the correlation between the Dry Fork Snotel precipitation data and the annual cycles of flow from the dumps for 2002 to 2005. The 2002 to 2005 data set are the most complete and show this trend.
11	App A Page 22 Table 6	See comment 1 listed above (also page 25 paragraph 3).	Added clarification to Appendix A, page 23 of 31 regarding origin of CH / MH soils. These materials appear to be derived from bands of volcanic materials that outcrop below south dumps.
12	App A Page 23 Figure 5	Graph notes in December 99 the leaching termination is “planned”. Update graph to 2009 at a scale which would show seasonal fluctuations.	This figure was updated.

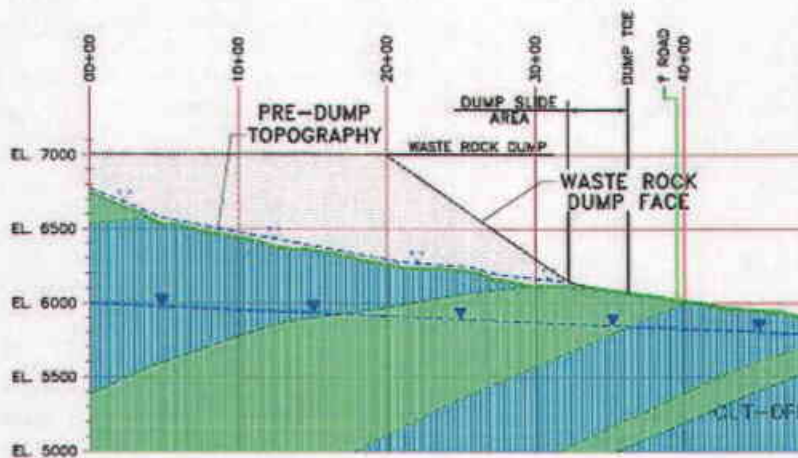
Figure A-4 - NAE cross section through Yosemite dump showing sedimentary deposits

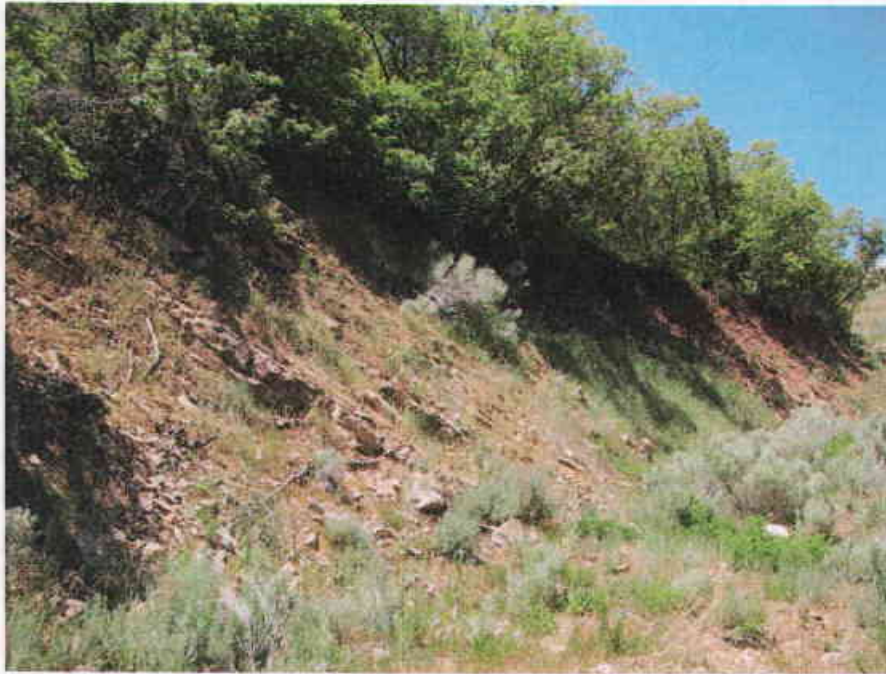
*Figure A-5 – Soil development along the north facing Castro drainage. Note shallow bedrock is still present and considerable float occurs.*

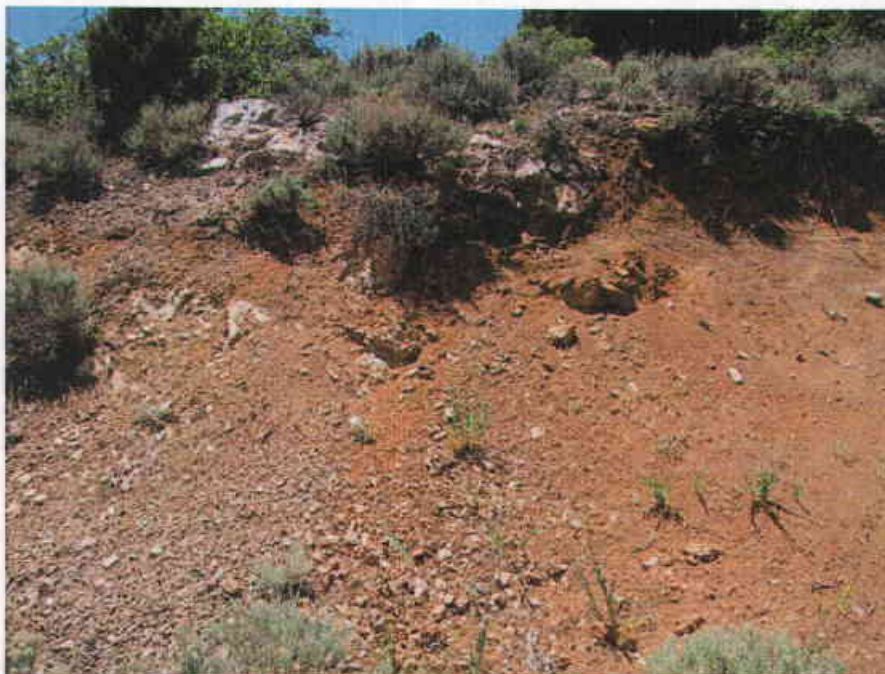
Figure A-6 – Transition area from thin soil layers (east facing) to thicker soil layers (north facing) near the Olsen drainage

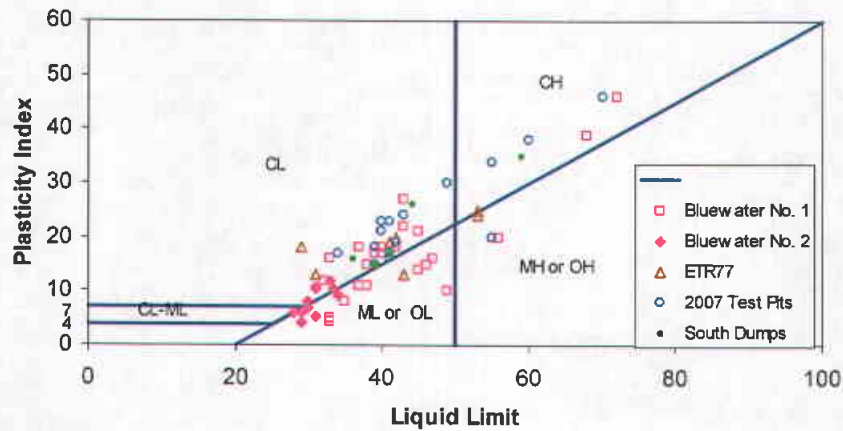
Figure A-8 - Atterberg limit tests showing correlation of 2007 and 2008 samples with previous test work (South Dumps are 2008 tests).

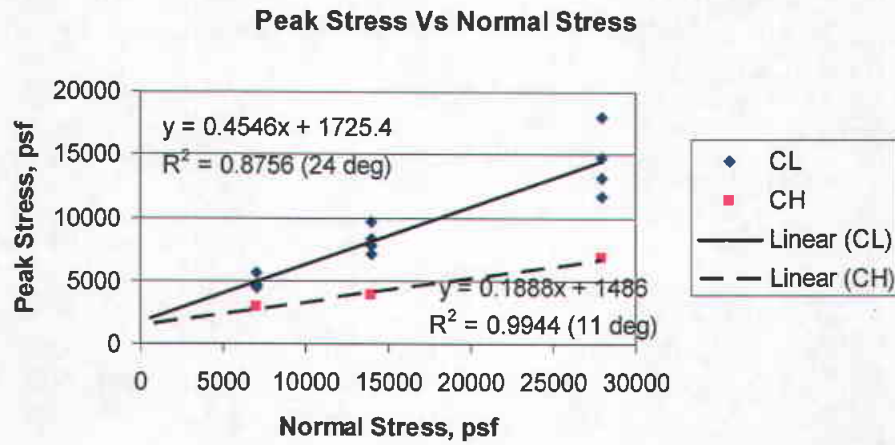
The highly plastic CH and CL soils are generally associated with residual soils developed from underlying weathered volcanic bedrock or transported from weathered, up slope volcanic bedrock. Below the South dumps, the volcanic bedrock is present within "bands" of sedimentary materials generally trending in a southwest to northeast orientation. In addition to previous testing, an additional six direct shear tests were completed on low plasticity CL soils and one supplemental direct shear test was completed on CH soils. These results were combined with previous two tests to develop representative drained, consolidated shear strength data on the CL and CH soils, respectively. Results of the available direct shear testing are presented on Figure A-9. Individual test results are presented in attachment E to this Appendix.

Figure A-9 - Summary of direct shear strength test results

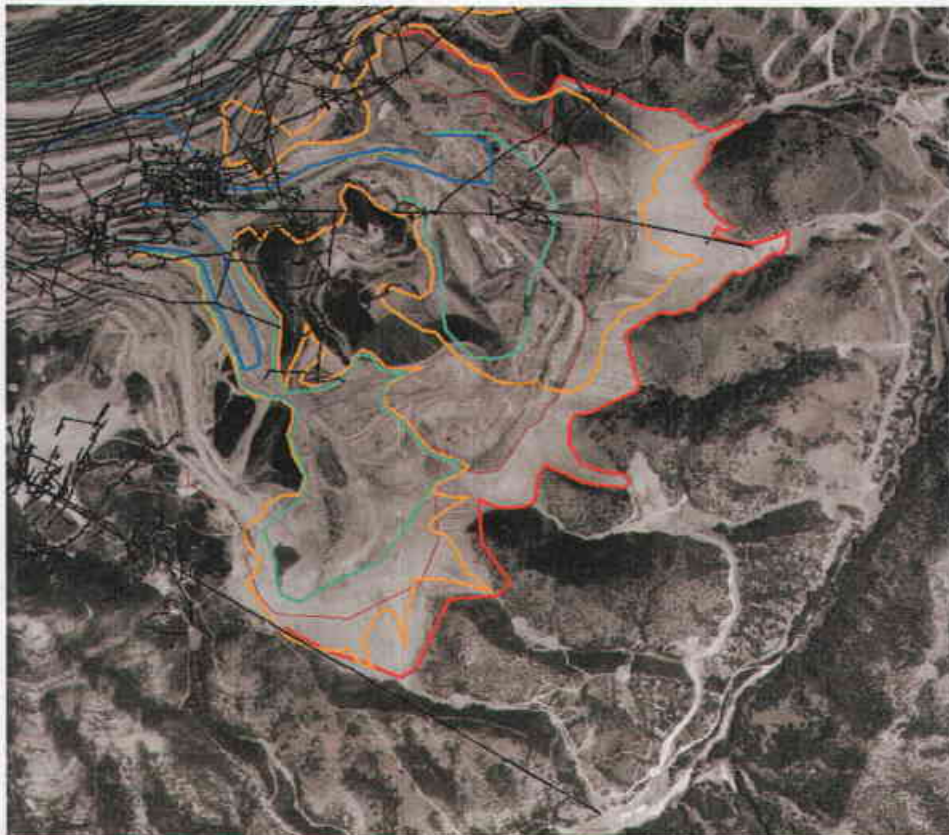
Historical mining has resulted in a number of underground tunnels and adits in proximity to the dumps. KUCC has developed a plan map of the underground workings and incorporates this information 3-dimensionally into the MineSight model. A 2-dimensional portrayal of the underground workings is shown on Figure A-10. It is observed that the Saint Joe tunnel extends below the ridge between the Yosemite and Saint's Rest drainages. The Butterfield tunnel extends along the South end of the South waste dumps and does not appear to lie below the dumps. No other tunnels are present below the South end dumps.

Figure A-10 - Projection of underground workings below KUCC South Dumps. The upper black line is the Saint Joe tunnel and the lower black line is the Butterfield Canyon tunnel (Red line = 1990 limits of dumps, orange line = 1980 limits, blue lines is 1970 and earlier)

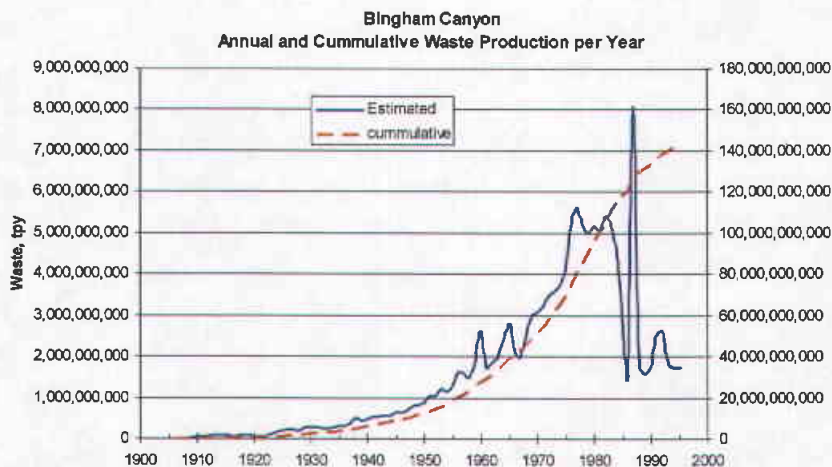
Figure B-1 - Estimated Waste Placed at Bingham Canyon from beginning of open pit mining to the mid-1990's (estimated from ore production and stripping ratio)

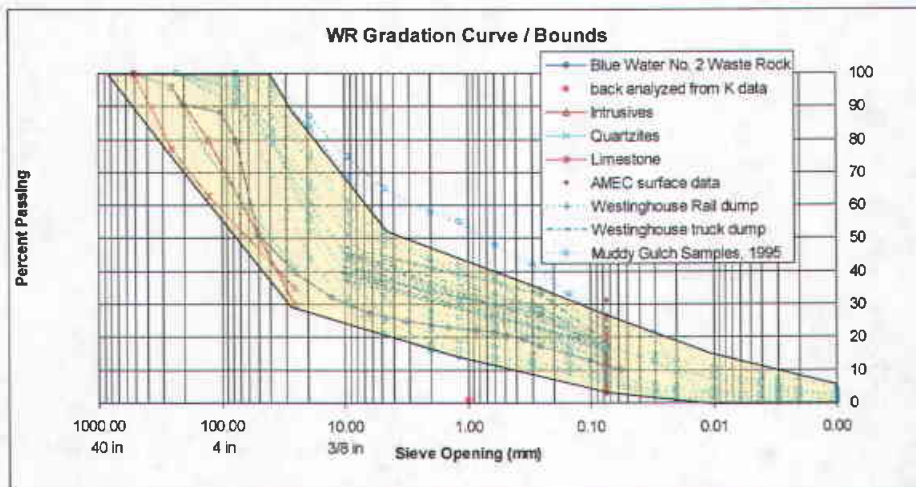
Figure B-2 - Summary of WR dump gradation data based on previous investigations (KUCC and AMEC data)

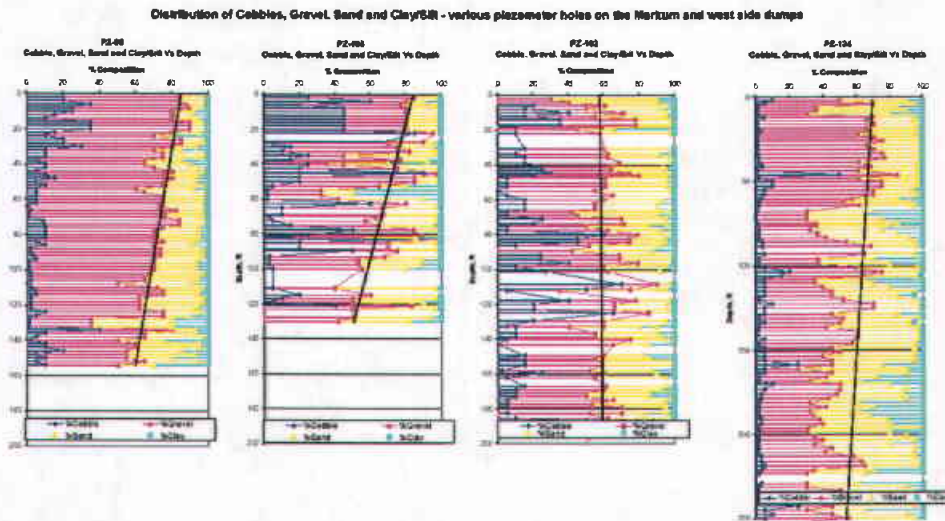
Figure B-3 – Distribution of cobble (blue), gravel (magenta), sand (yellow) and silt/clay particles sizes versus depth based on Sonic core (visual / manual method).

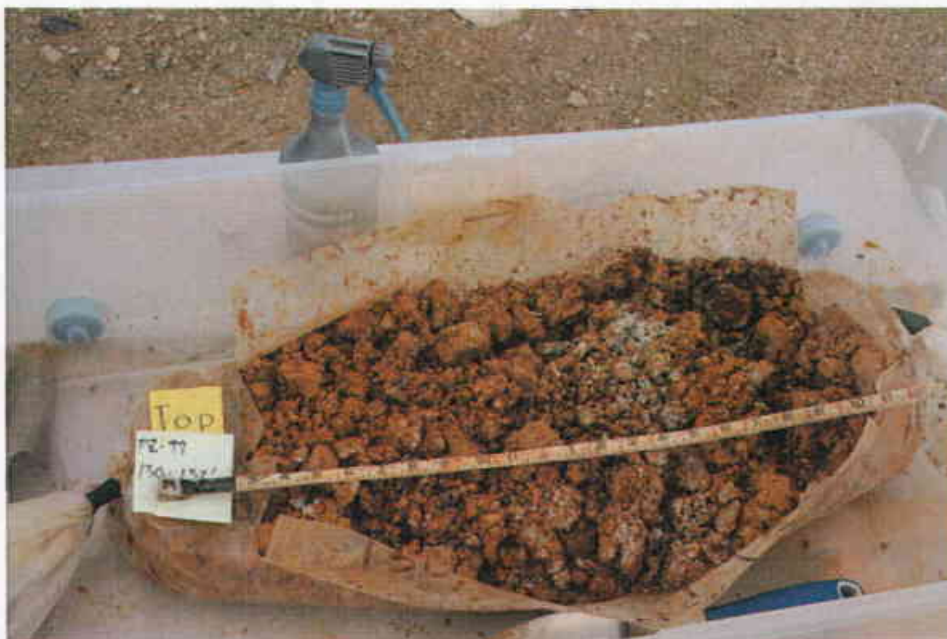
Figure B-4 – Typical Sonic core in plastic jacket.

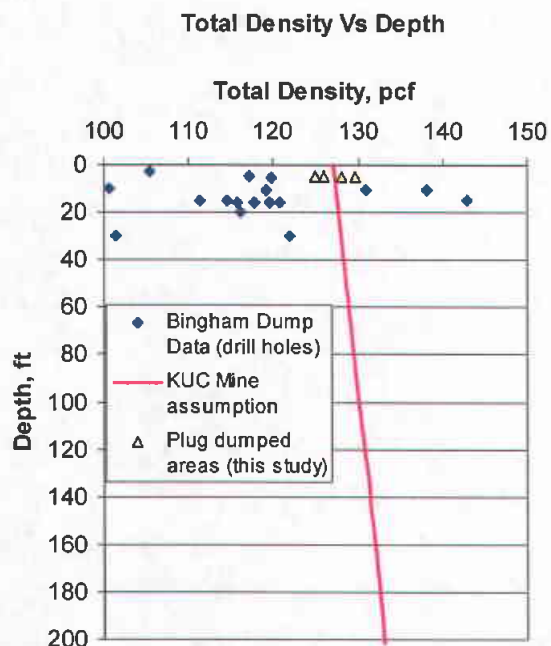
Figure B-6 Density Data (KUCC data)

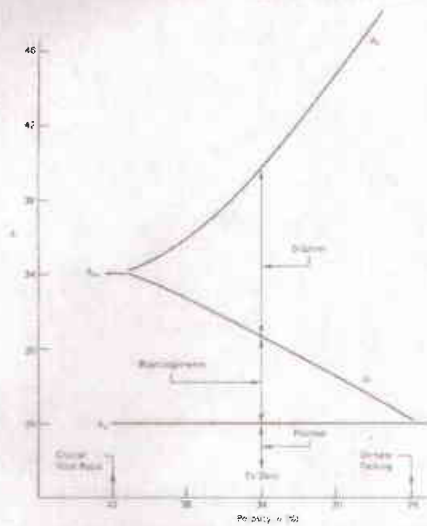
Fig. 14.58 Components of shear strength in granular soils (After Rowe, 1962)

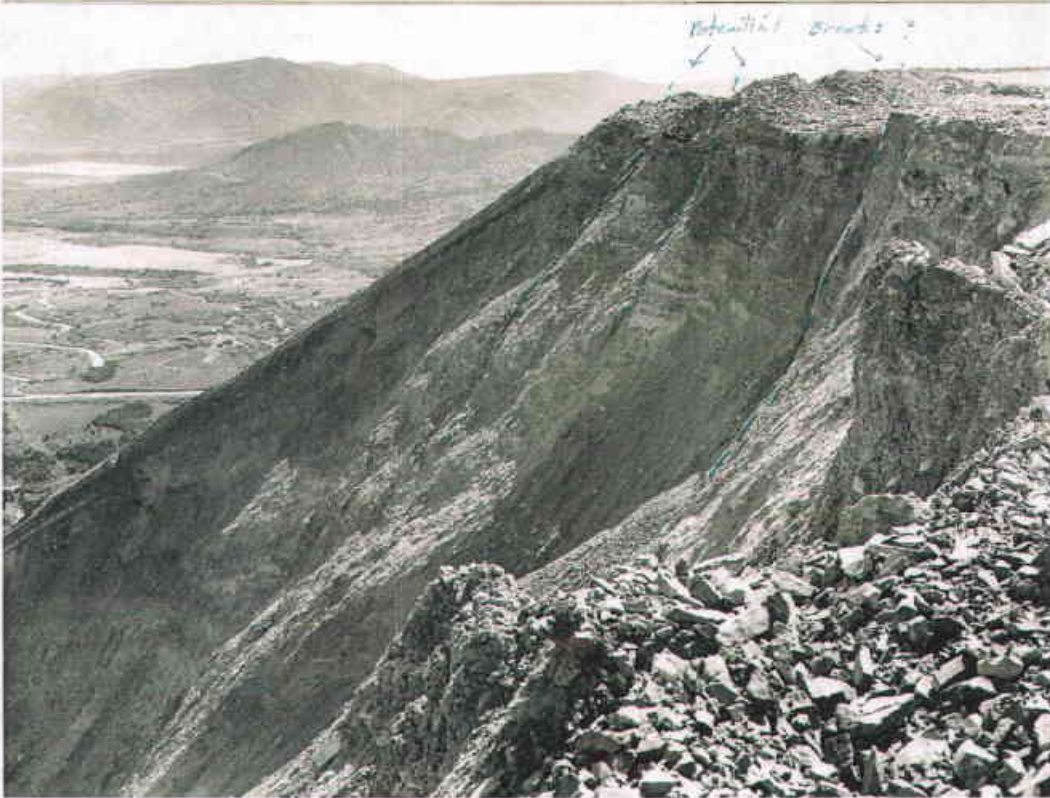
Figure B-9 – Stratification of a dump and horizontally bedded materials observed at depth (1979 photo, J Pilz)

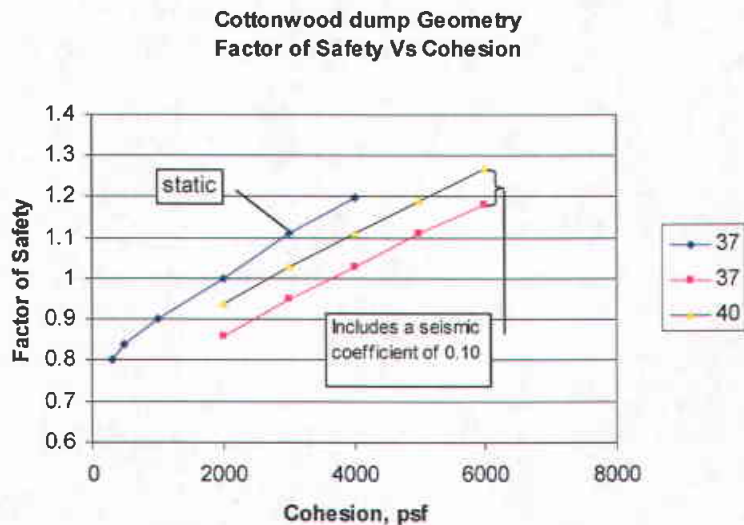
For the Cottonwood Dump geometry, a plot of the factor of safety versus minimum cohesion that must be present was prepared. A friction angle of 37 and 40 degrees was selected and the effect of a seismic coefficient to simulate the effect of pit production blasting was also included. The following graph shows the results:

Figure B-11 - Factor of safety versus cohesion for a well cemented dump

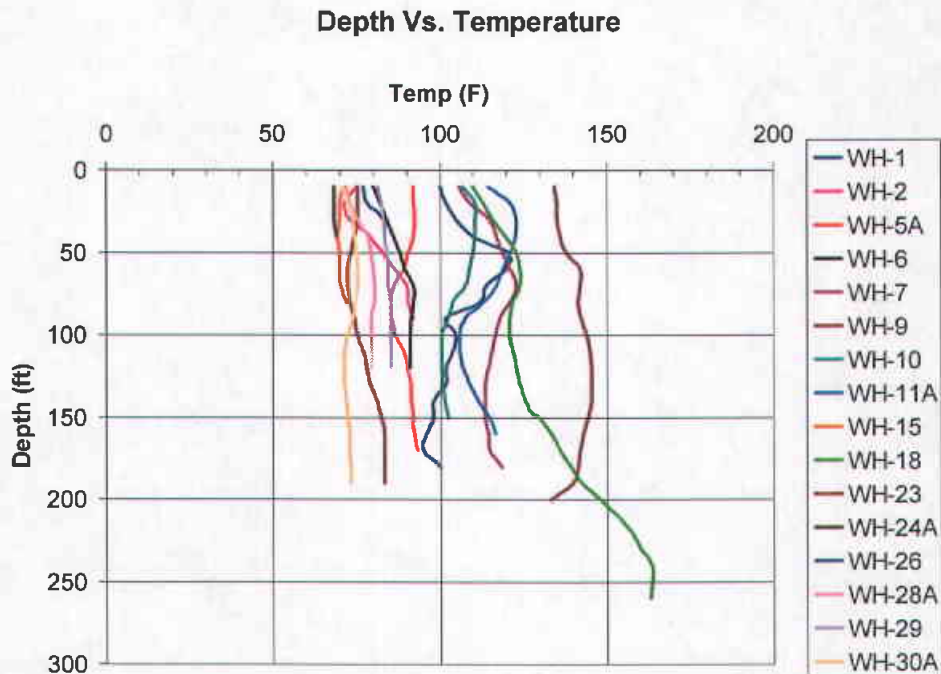
Figure B-12 – Available Temperature Data (Wyoming Mineral drill hole data)

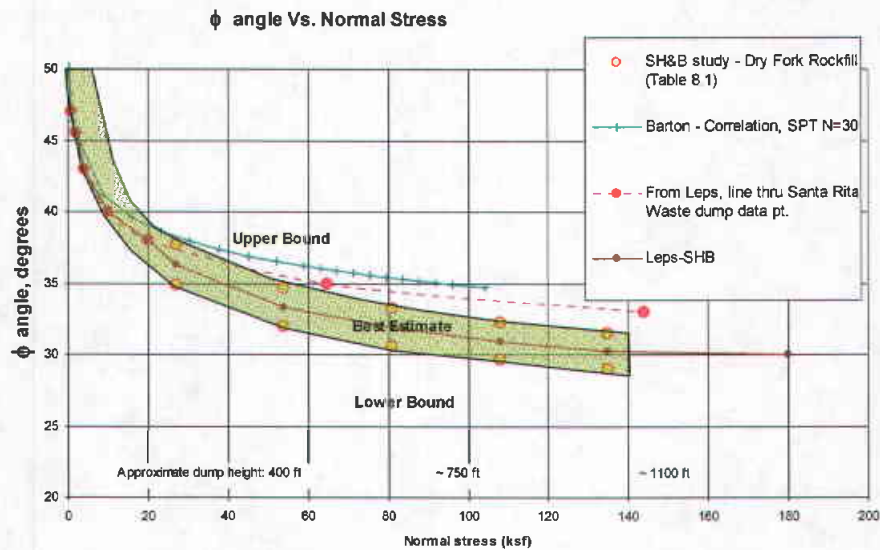
Figure B-13 - Best Estimate of Waste Rock Shear Strengths

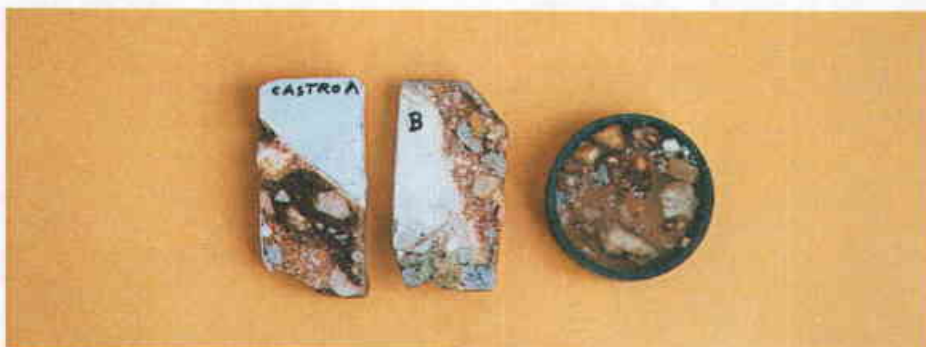
A ferricrete such as illustrated in the two clasts on the left side of Figure 2, must be sawed with a diamond blade or broken by percussion with a heavy hammer

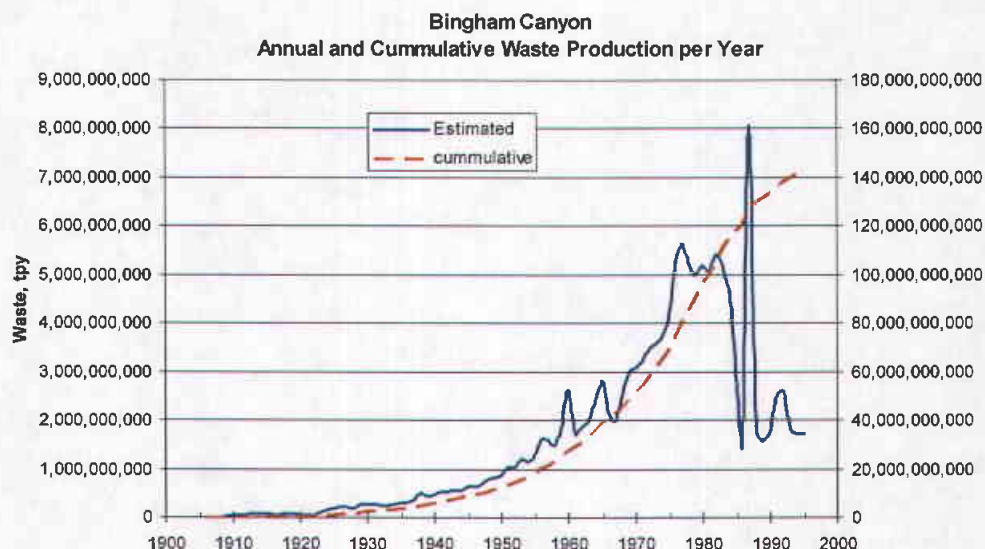
Figure D-1- Estimated Bingham Canyon waste production estimated from ore production and strip ratio (after Krahulec, 1997)

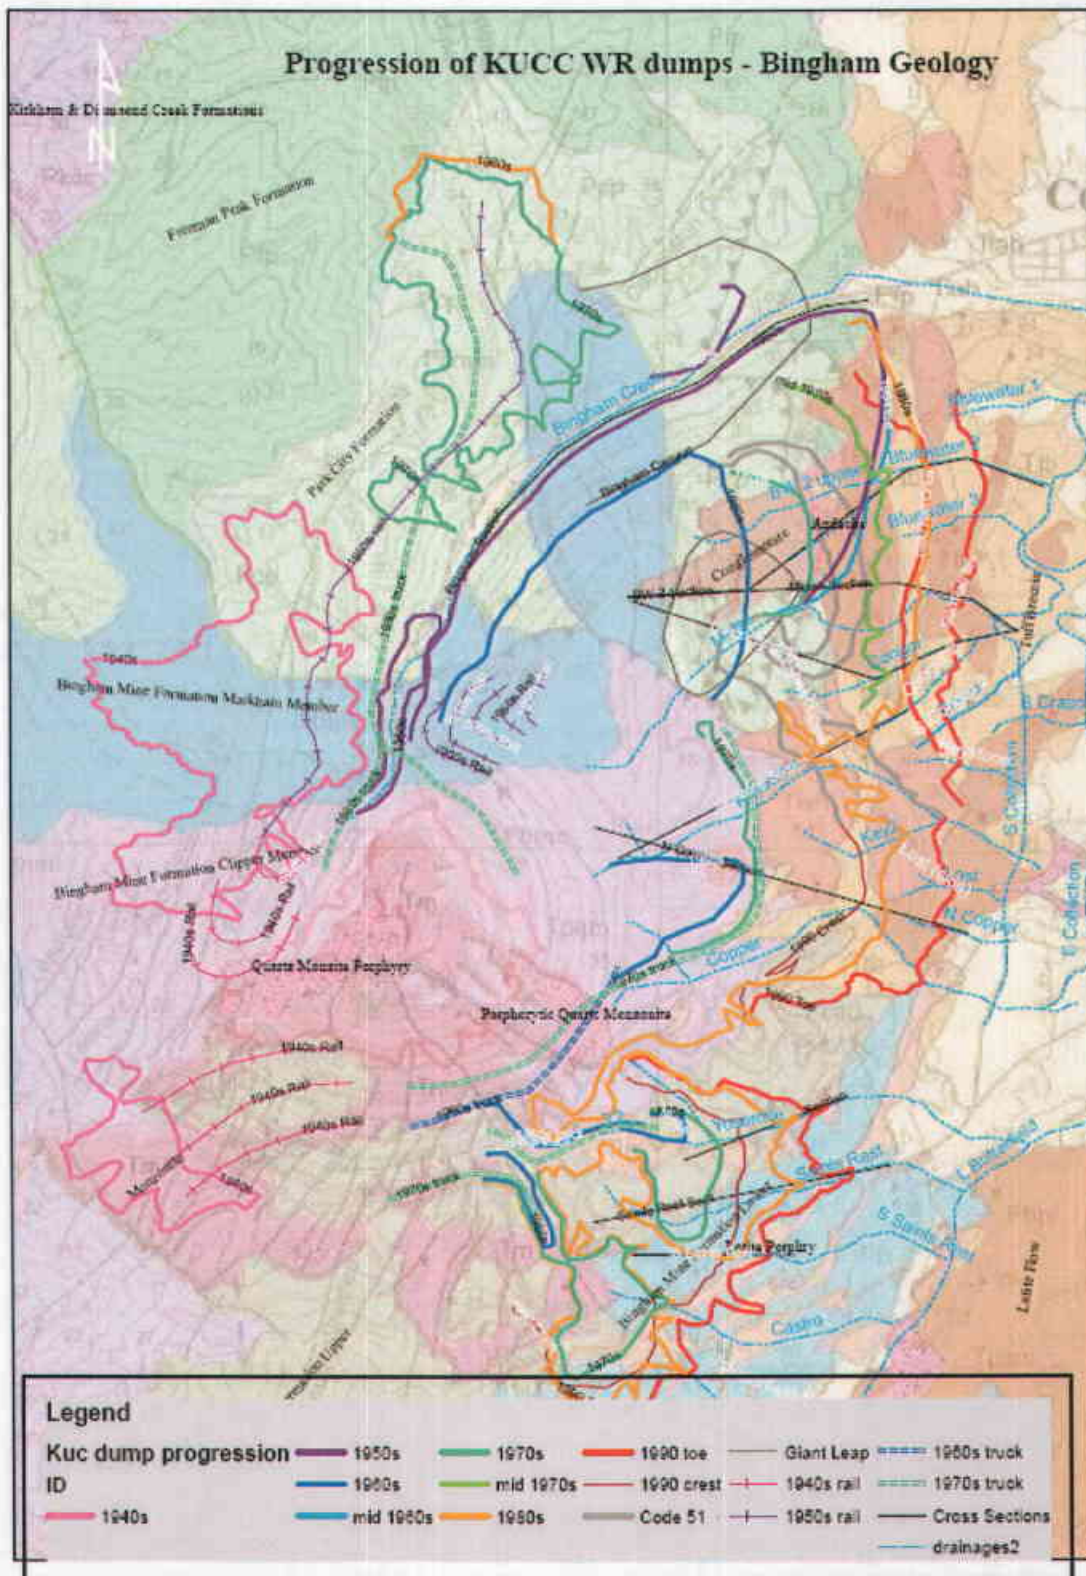
Figure D-3 - Extent of dumps overlying Bingham Geology dumps

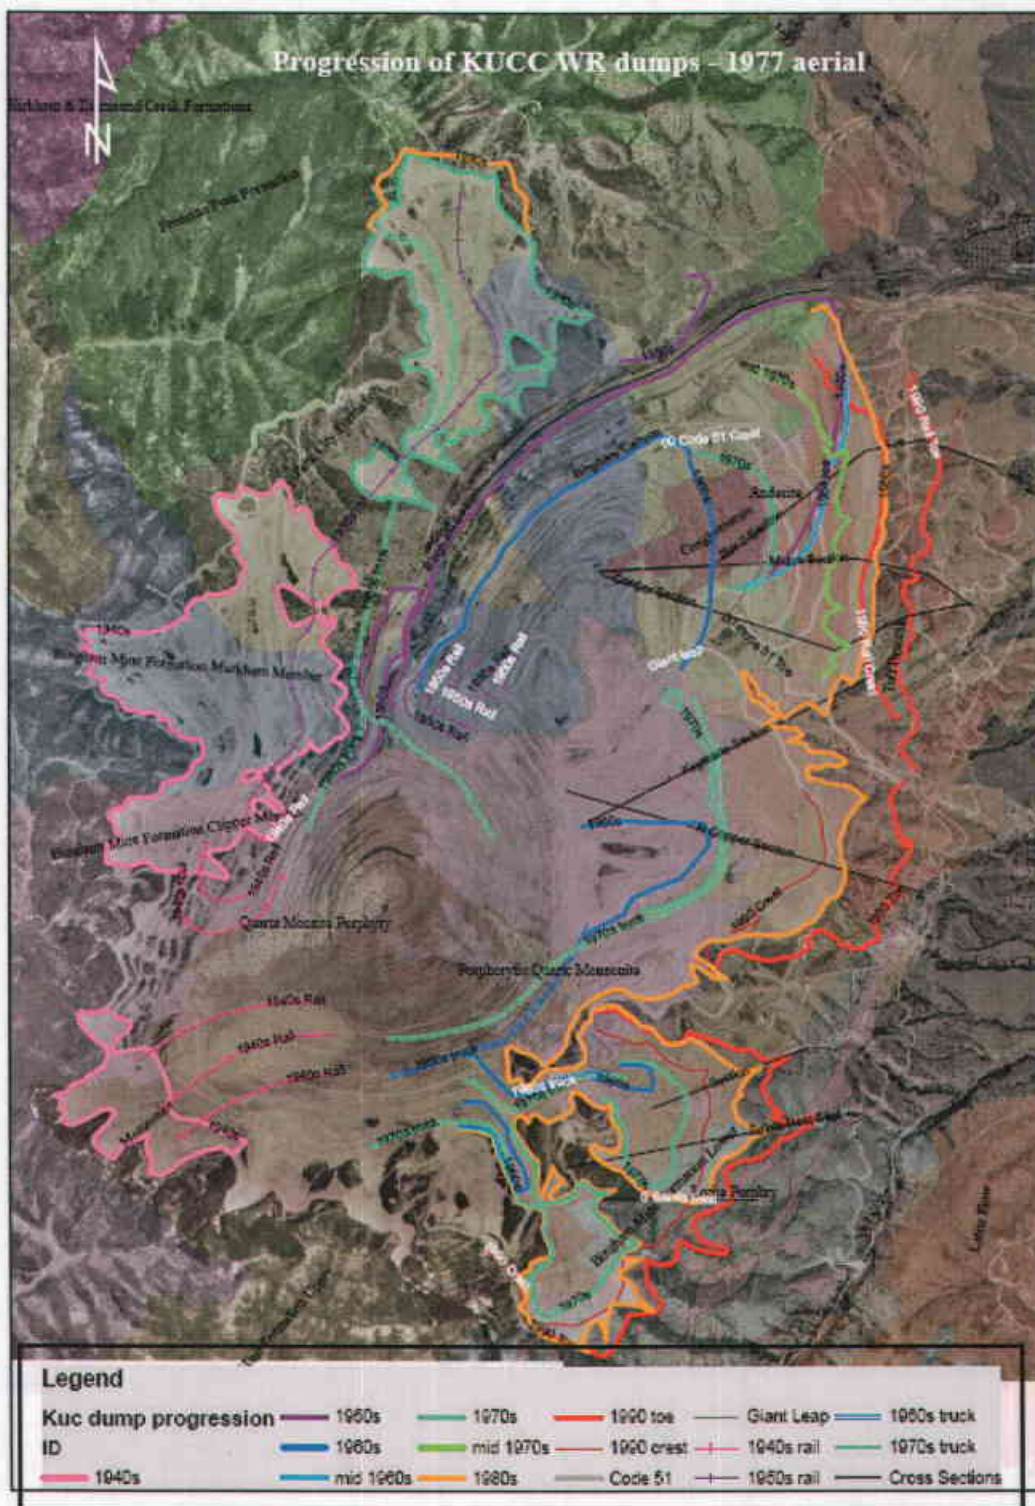
Figure D-4 Extent of dumps overlying a 1977 aerial photograph of the mine area.

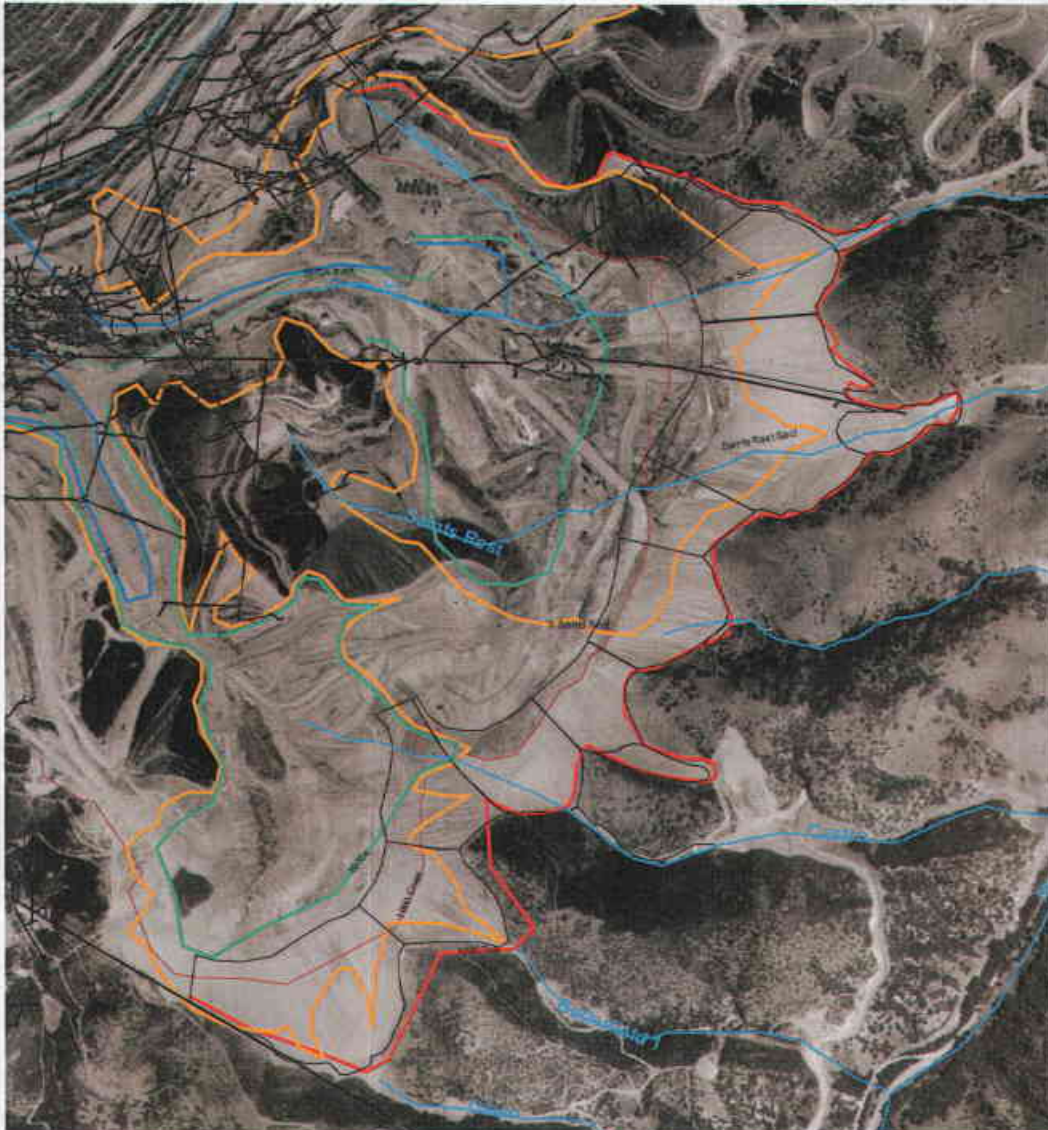
*Figure D- 6 - Detail of progression of the South End dumps overlying historic underground workings*

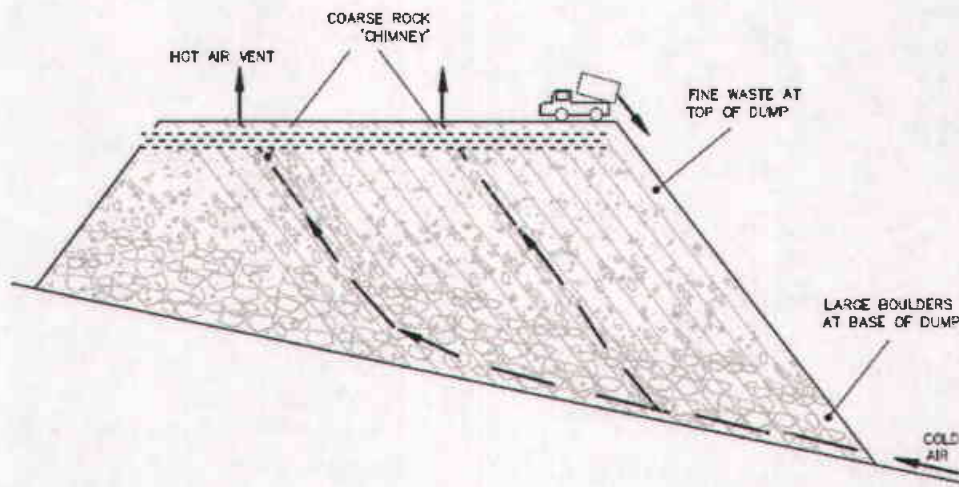
Figure 1 - Typical dump deposition (modified after [www.infomine.com](http://www.infomine.com)). A zone of horizontal stratification has been added at the dump crest to simulate short dumping to maintain dump elevation due to dump settlement. Coarse rock chimneys are zones where heat released during acid generation is released.

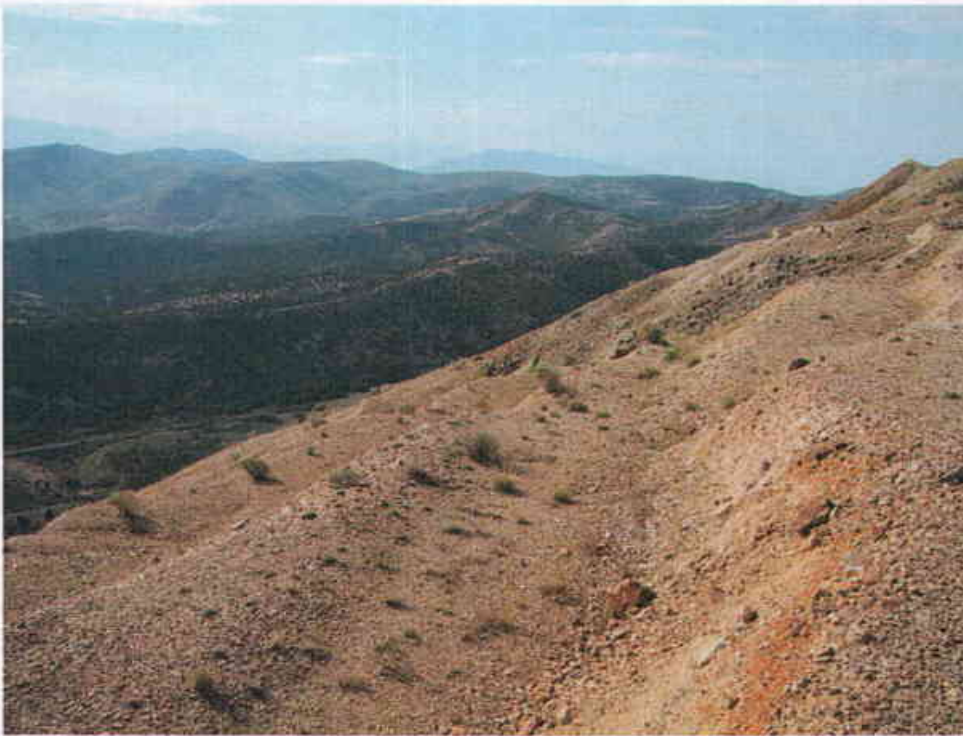
Figure 2 – View of settlement cracks and surficial movement at crest of Yosemite dump. There is abundant evidence that shallow slips of the surface continue to occur. Tension cracks are sometimes observed as far back as 500 feet from crest. Cracks tend to “heal” themselves over time. Survey monuments situated up slope of these cracks settled 3 ½ to 4 ½ inches from Oct 2005 to April 2007. Displacement along these scarps is much greater and on the order of tens of feet.

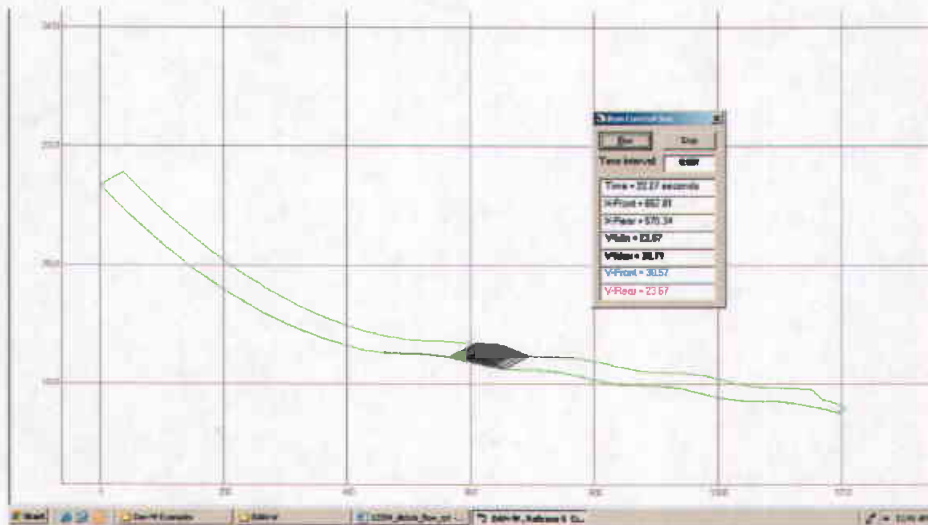
Figure 3 - Dan-W output showing debris flow "slug" travelling down terraced apron

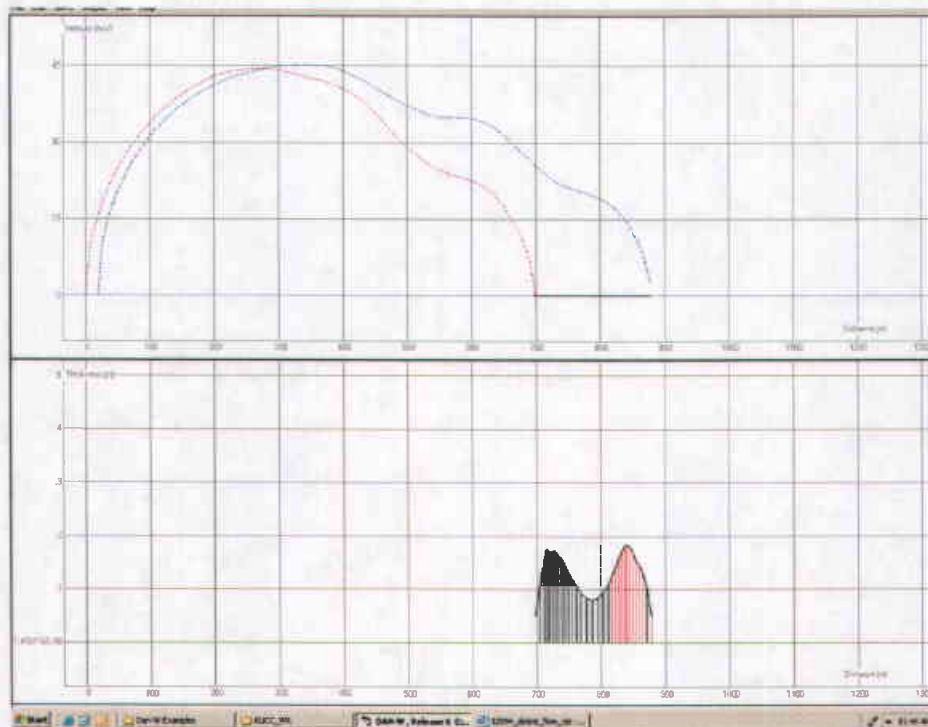
Figure 4 - Dan-W velocity, travel distance and depth of deposition graph

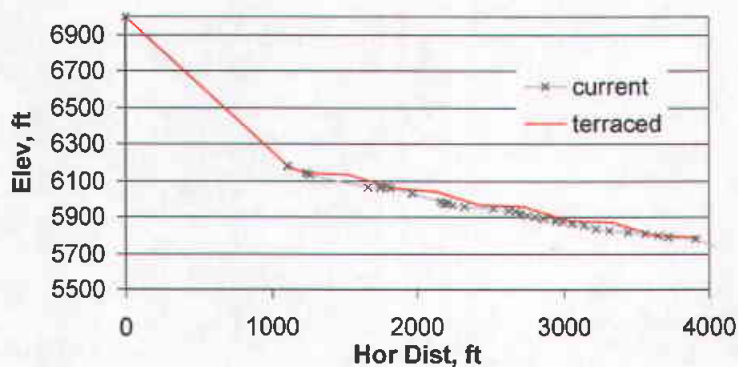
Figure 5 - Possible terracing of dump toe (2 degree benches with 12 degree terrace slopes shown)

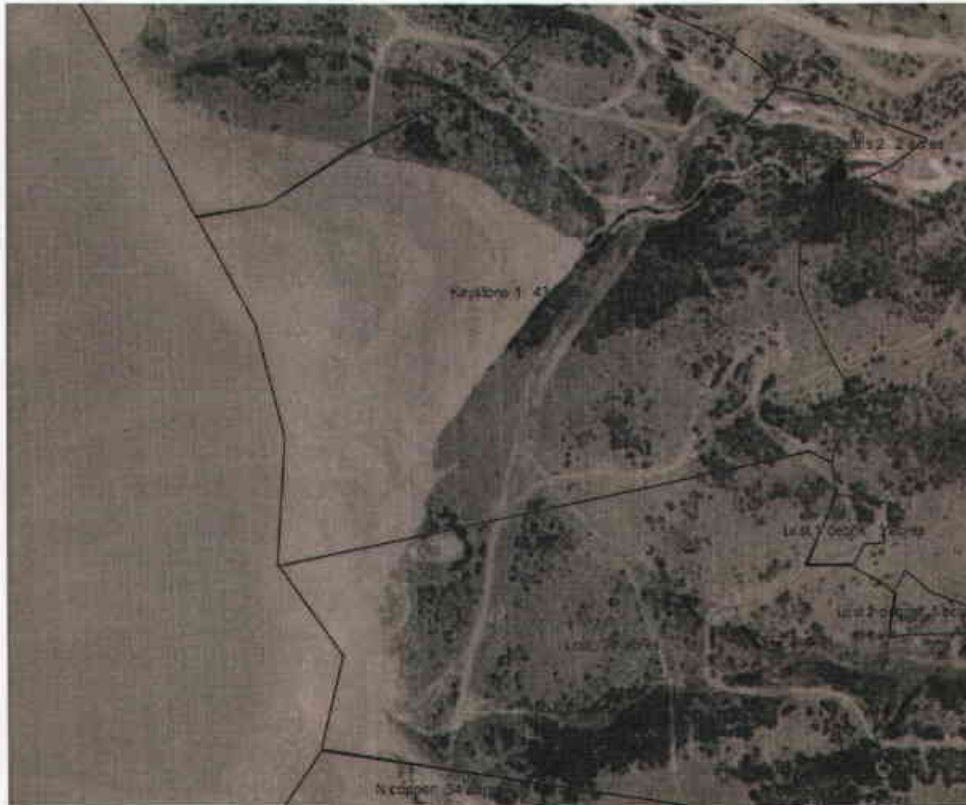
Figure A-6 - Footprint below the Keystone dump in 1977 – debris from previous failure is evident.
